### STM32F405/407xx and STM32F415/417xx device errata

This document applies to the part numbers of STM32F405/407xx and STM32F415/417xx devices and the device variants as stated in this page.

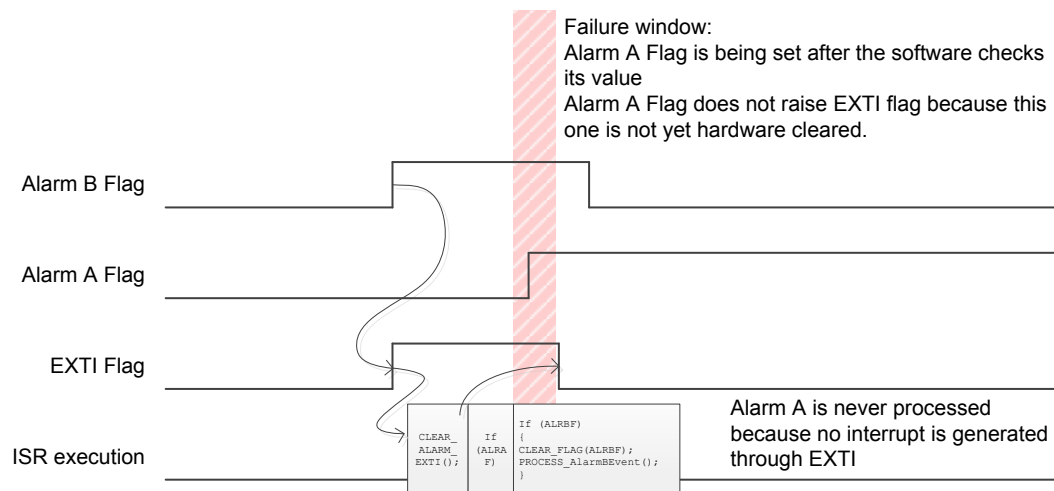
**Figure 1. Masked RTC interrupt**

The following code example and figure illustrate the failure mechanism: The Alarm A event is lost (fails to generate interrupt) as it occurs in the failure window, that is, after checking the Alarm A event flag but before the effective clear of the EXTI interrupt flag by hardware. The effective clear of the EXTI interrupt flag is delayed with respect to the software instruction to clear it.
