## STM32H7Rxx/7Sxx device errata

This document applies to the part numbers of STM32H7Rxx/7Sxx devices and the device variants as stated in this page. It gives a summary and a description of the device errata, with respect to the device datasheet and reference manual RM0477. Deviation of the real device behavior from the intended device behavior is considered to be a device limitation. Deviation of the description in the reference manual or the datasheet from the intended device behavior is considered to be a documentation erratum. The term “errata” applies both to limitations and documentation errata.

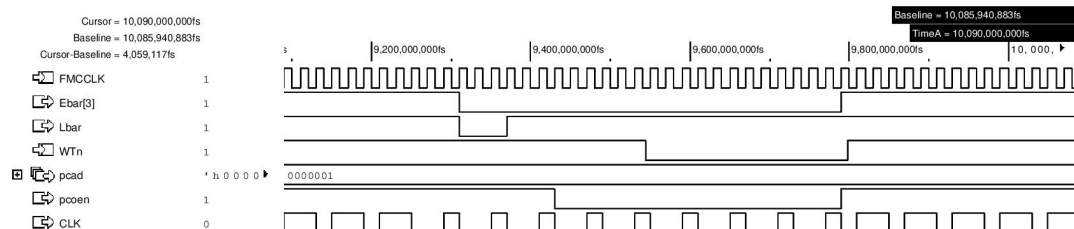
Figure 1. RTL simulation timing diagram

With a clock division of 3 (CLKDIV = 0x02), the FMC continuous clock duty cycle, which is 2/3 high and 1/3 low during read or write transfers, changes to 1/3 high and 2/3 low on the first clock after transfer. The duty cycle change creates a narrow pulse after the data transfer, as illustrated by Figure 1 below.

The narrow pulse after a data transfer is not expected to cause a timing violation for PSRAM, as CLK may be off and irrelevant after the transfer is complete.
